Wet Walls and Efflorescence

What Efflorescence is and How to Avoid It

By L. A. PALMER, Research Associate

Results of two investigations conducted at the National Bureau of Standards, U. S. Department of Commerce, Washington, D. C., George K. Burgess, Director

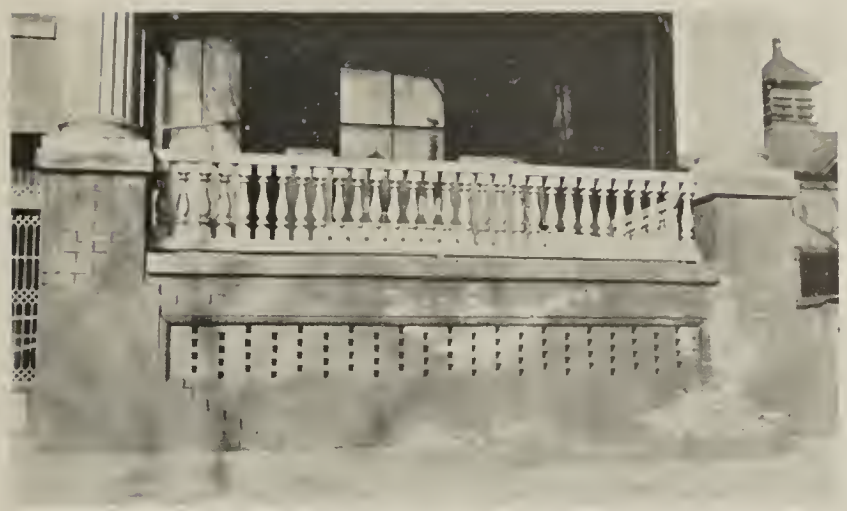
Figure 7. The stone coping has broken loose from the adjoining masonry, allowing water to enter the brickwork.

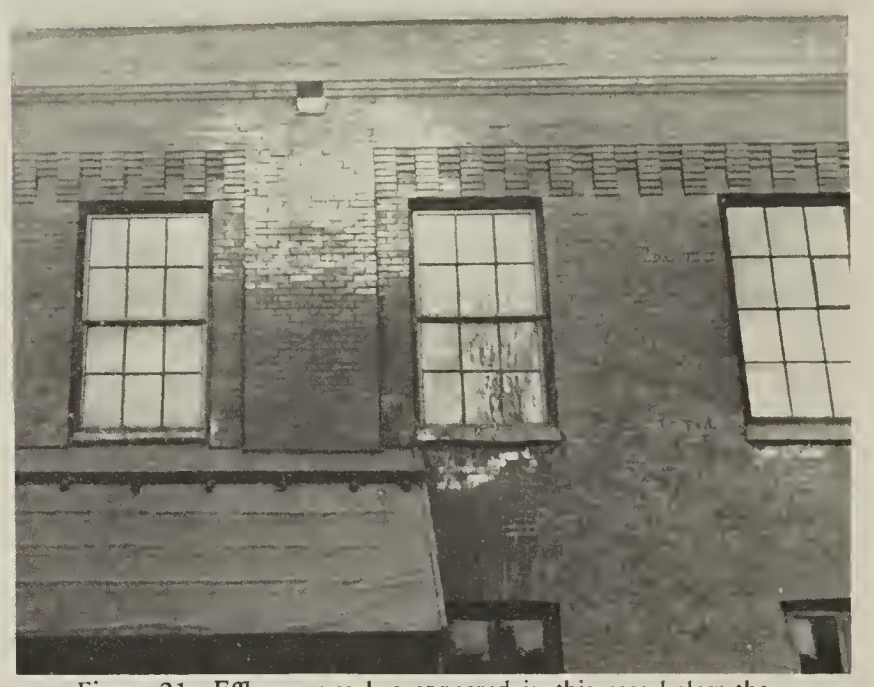
Figure 21. Efflorescence has appeared in this case below the water exit in the parapet wall.

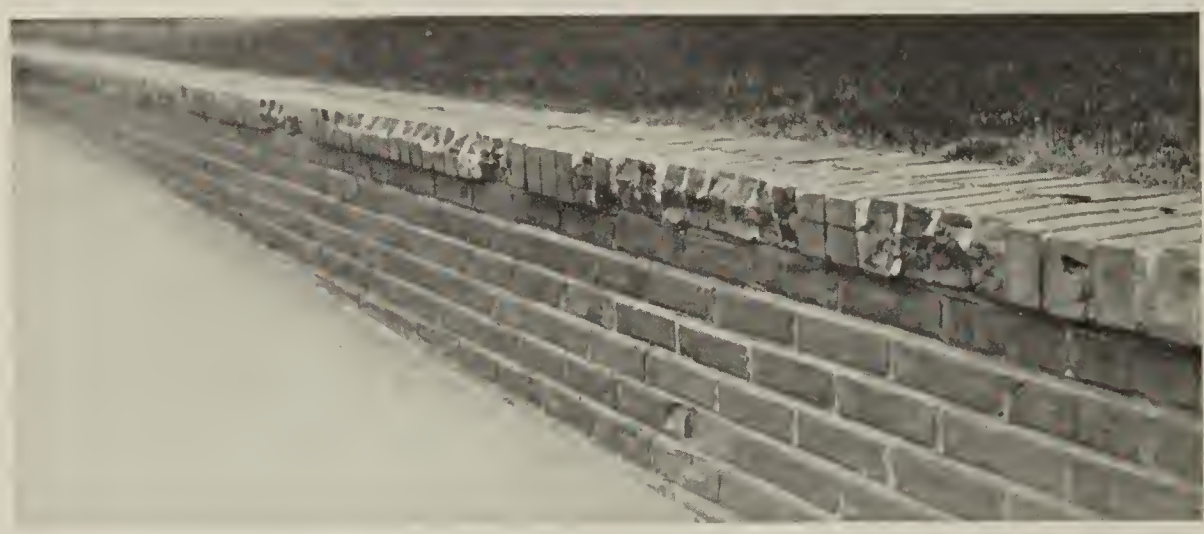
Figure 31b. In retaining walls, the exposure is especially severe. Even well-burned brick, such as were used here, must have adequate drainage to resist frost action.

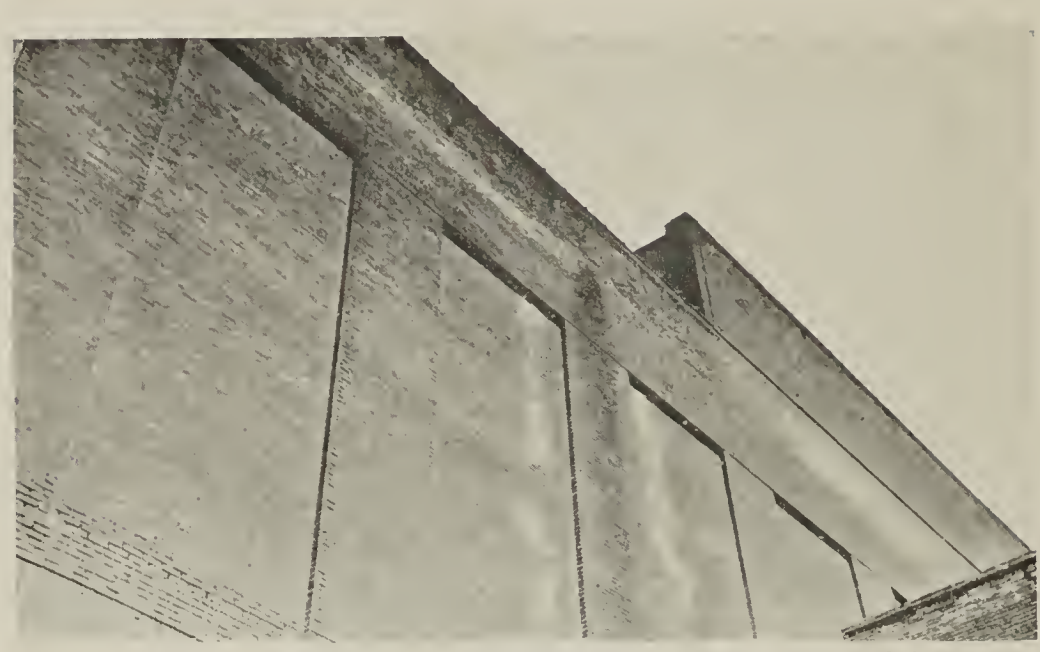
Again, to further illustrate combined faulty design, construction and maintenance, consider **FIGURES 35a, 35b, 35c** and **35d,** all pictures of the same building although parts of an adjacent building are seen in **FIGURES 35a** and **35c.** This was originally Condition B, without doubt. Kiln run common brick, a portion of which are underburned, compose the wall. **FIGURE 35d** shows the extent to which these brick as well as the intervening mortar joints near the soil have disintegrated. Efflorescence, very noticeable in the past, is becoming less noticeable at present while disintegration progresses. The walls have received quantities of water to wash out the salts for the most part. Galvanized iron which corrodes comparatively readily was used for flashing of the parapet wall which is about eight feet above the roof. There is both seepage and splashing, causing saturation of the lower wall. The coping is poorly designed. There are downspouts but these are inside the building and have undoubtedly become clogged. As a result, the overflow spouts have been called on to do the work with the results herein illustrated. As the joints progressively disintegrate the degree of saturation during a wet season increases. Below the wide recesses in the wall are projecting header courses of brick. It would be difficult to devise a more favorable condition for entrapping the maximum amount of moisture. Horizontal exposures are here unprotected by either sloping or by drips.

Figure 35a. This and the next three illustrations all show parts of the same building.

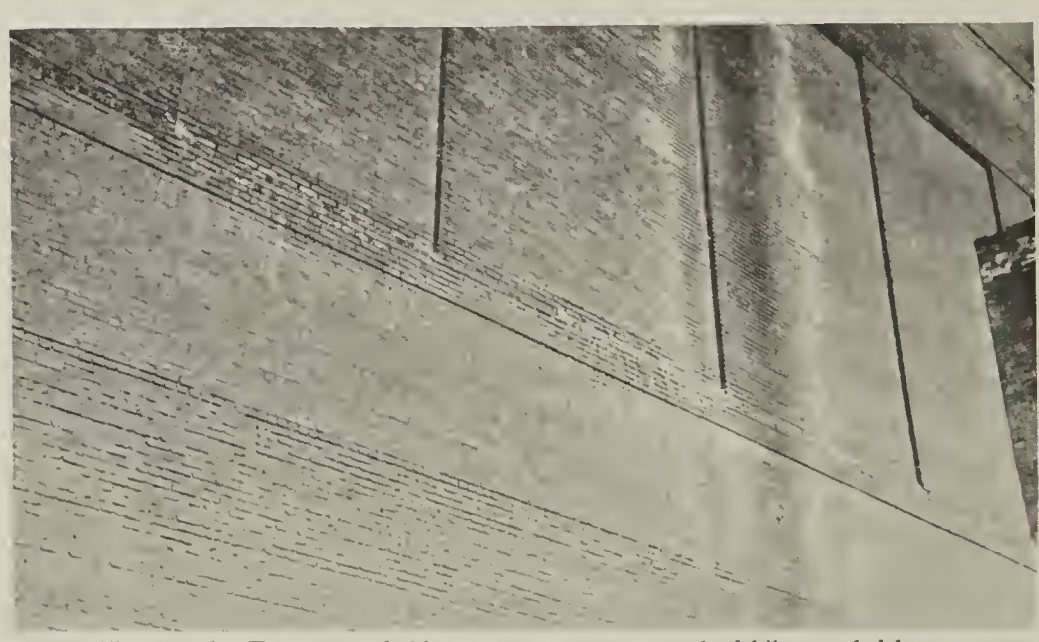
Figure 35b. The walls of this structure are composed of kiln run brick, some of which are underburned.

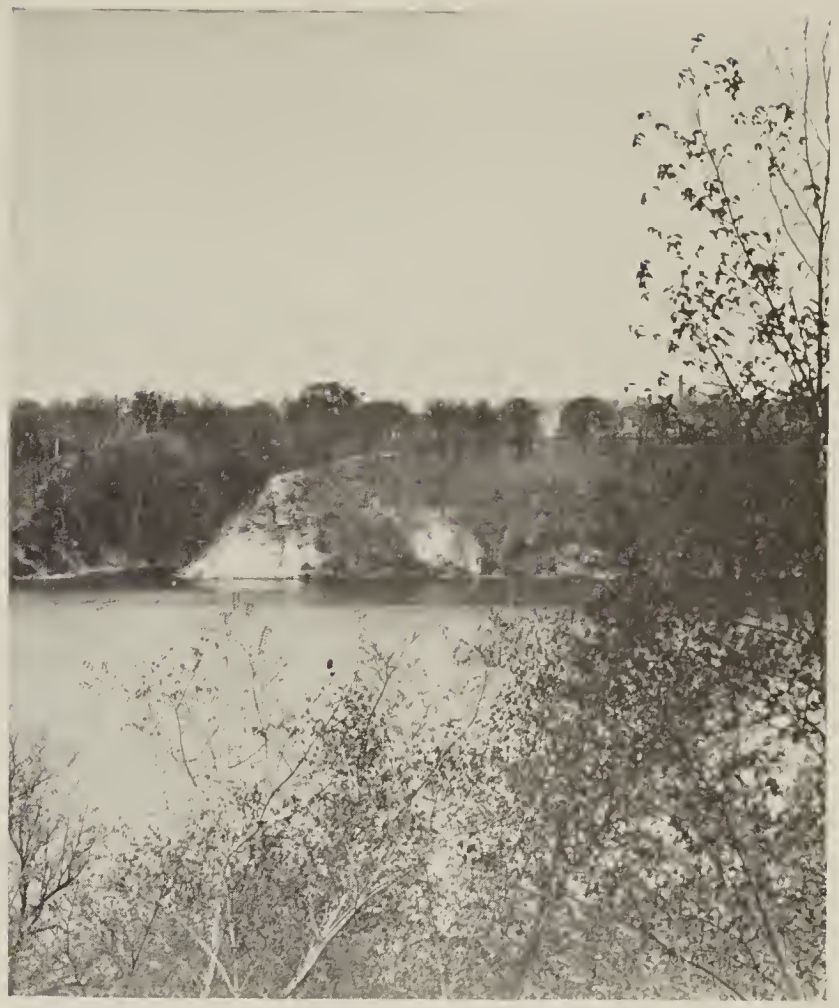
Figure 36a. Talus slopes such as this are common sights below cliffs of solid rock, along shore lines everywhere, for frost action is a relentless force, initiating the process of disintegration and opening the way for erosion by water and wind.

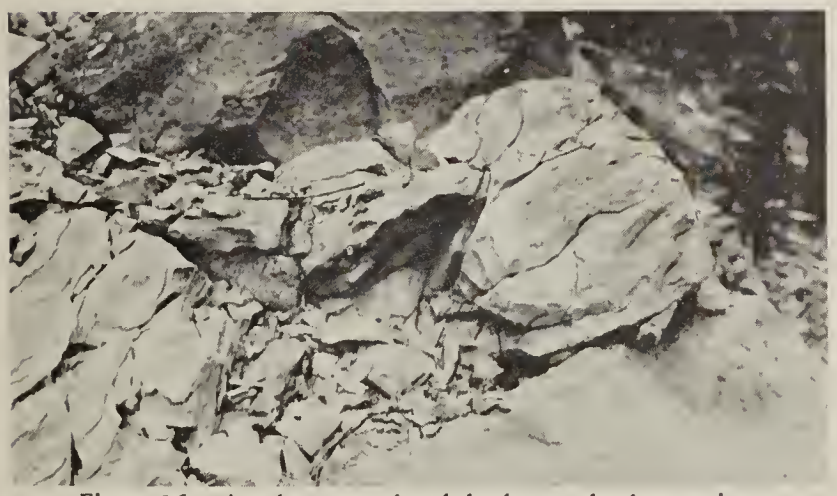
Figure 36c. Another type of rock broken up by frost action.
